Discontinuance of Herbst Appliance Therapy

FINAL REMARKS

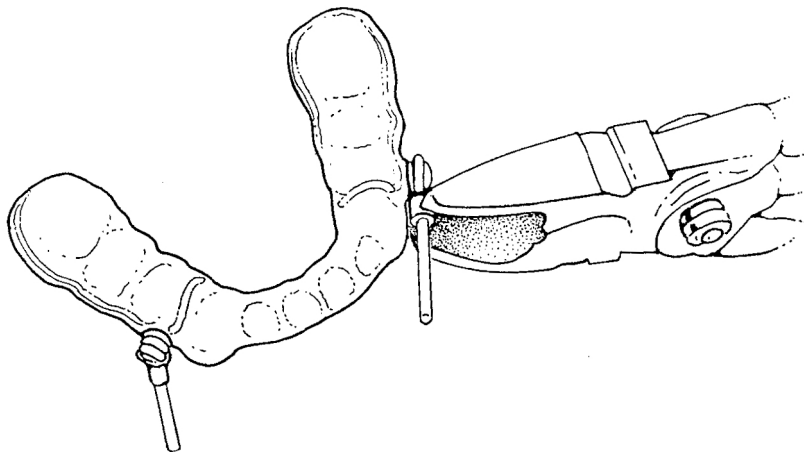
Figure 16. Advancement of the Herbst appliance. Heavy wire cutters are used to crimp the tubing sleeves on the mandibular plunger.
